Alternator Stator Failure and Repair

Revised 4-1-2009

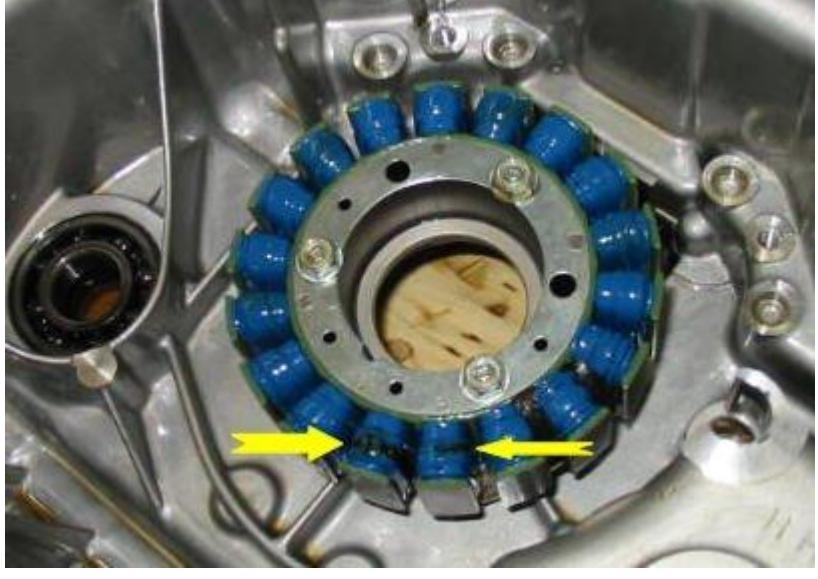
The first photo shows the new Electrex stator while it was still installed in the rear engine case. The discoloration highlighted in the photo indicates several turns of the wire have overheated. There is a strong possibility that the insulation has been compromised so the stator must be replaced or rewound.

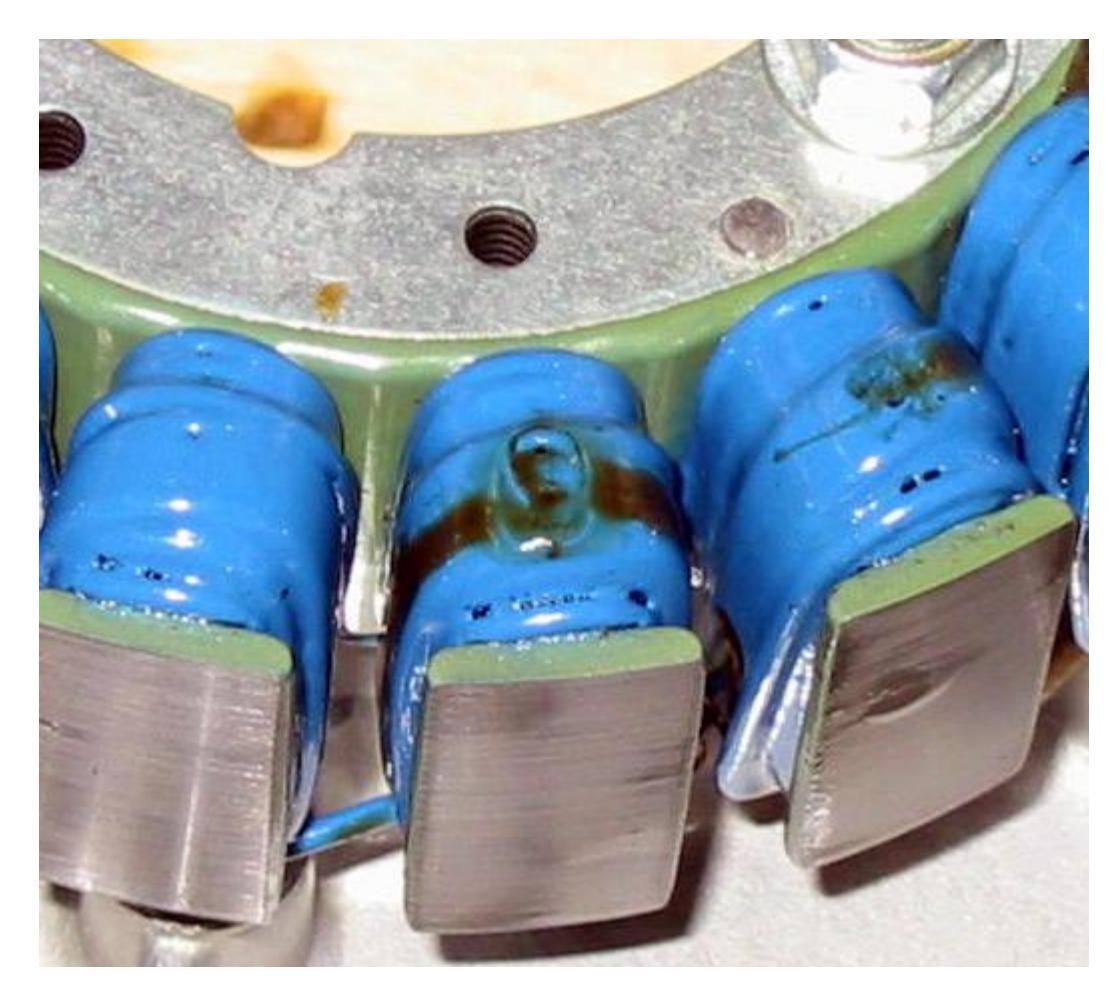
Here is a closeup view of the overheated wire turns.

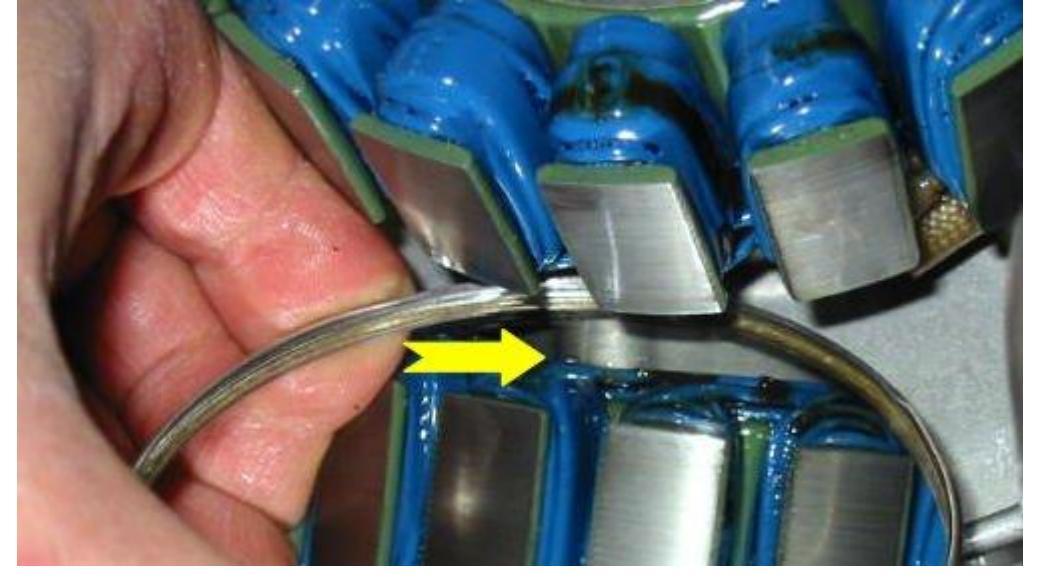
A wire underneath the stator can be seen touching the stator mounting shoulder in this photo.

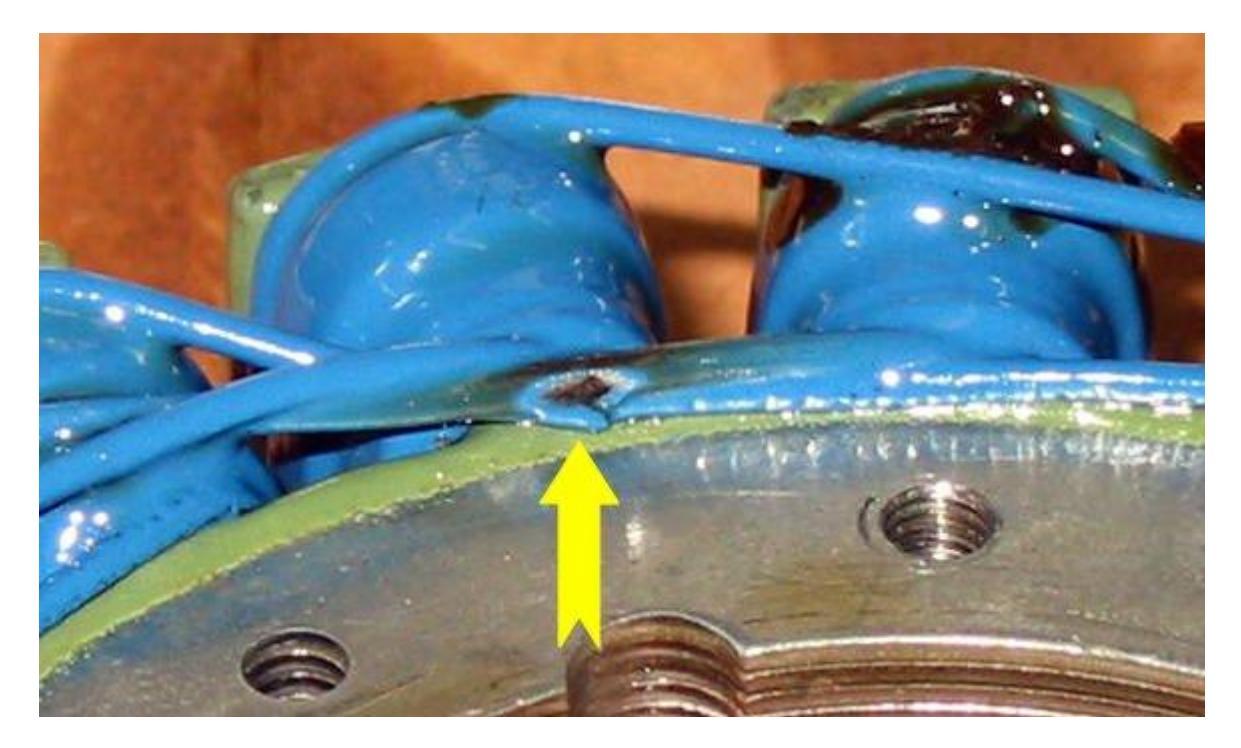
The stator was then removed from the rear engine case and set on the workbench. The place where the wire touched the mounting shoulder can be easily seen.

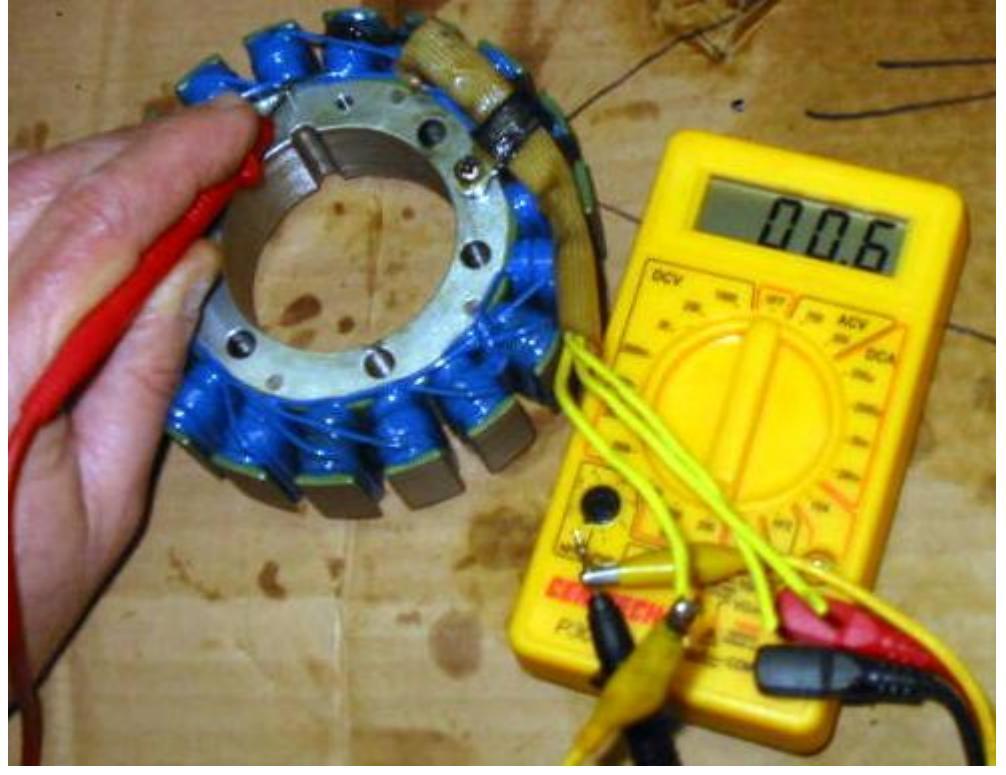
An Ohmmeter confirmed the short.

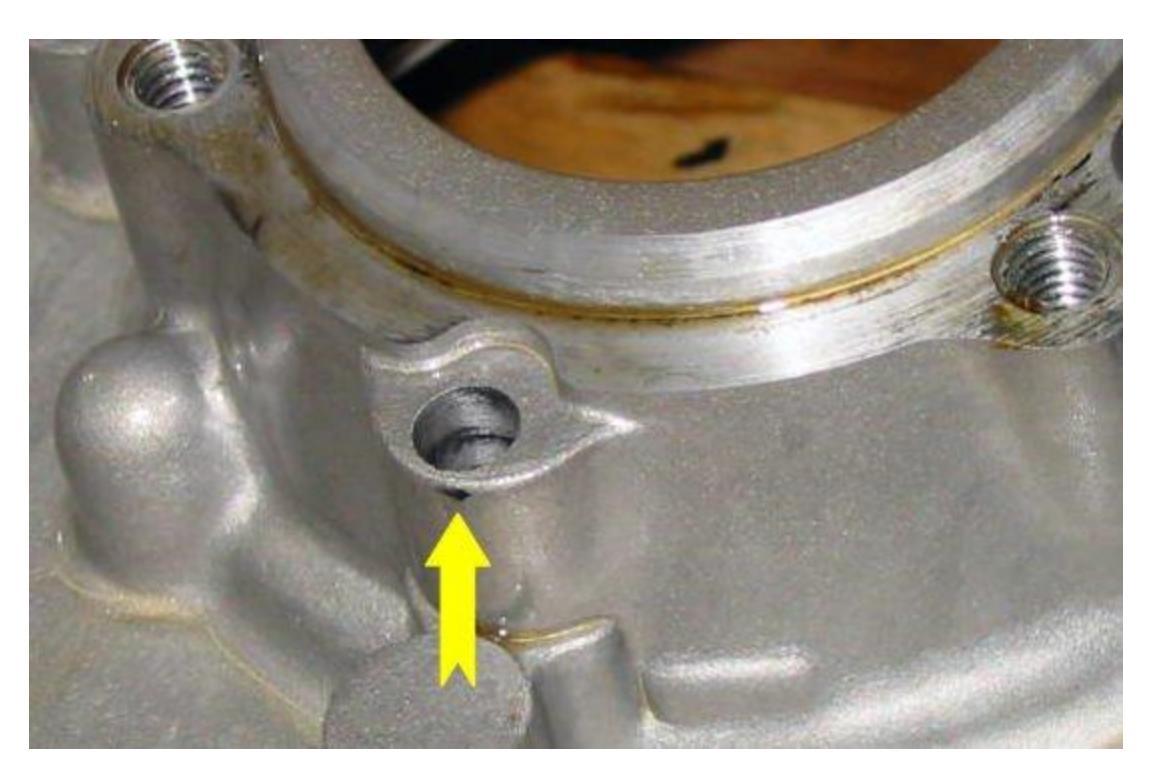
The corresponding location on the rear engine case mounting shoulder shows evidence of burnt insulation where the wire made contact.

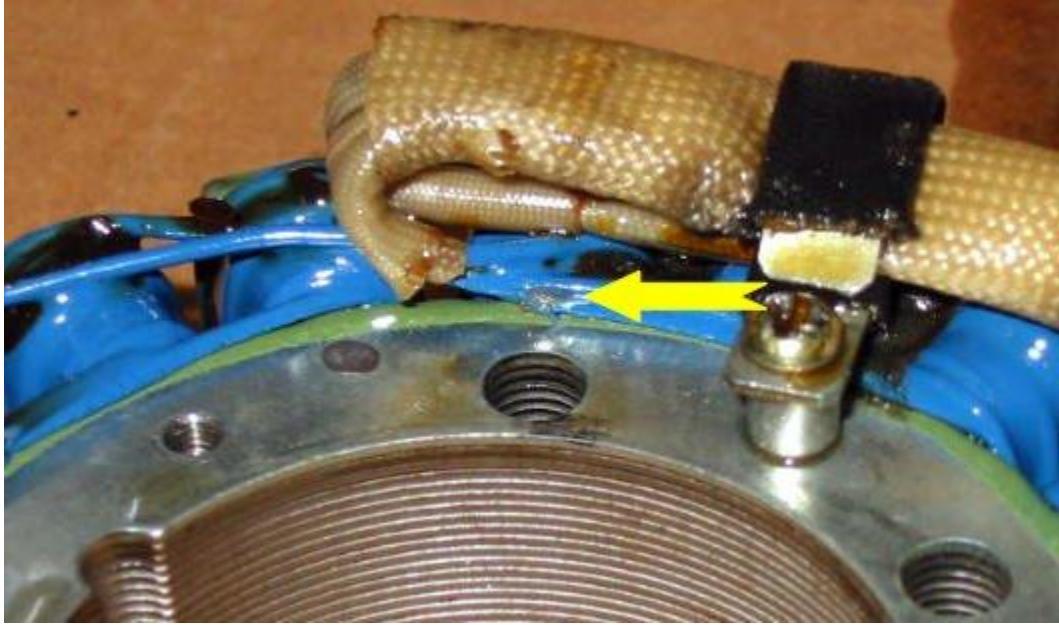
Another location was found where the stator wire made contact with the mounting shoulder. A short circuit had not formed here <u>yet</u> but the wire insulation was seriously deformed.

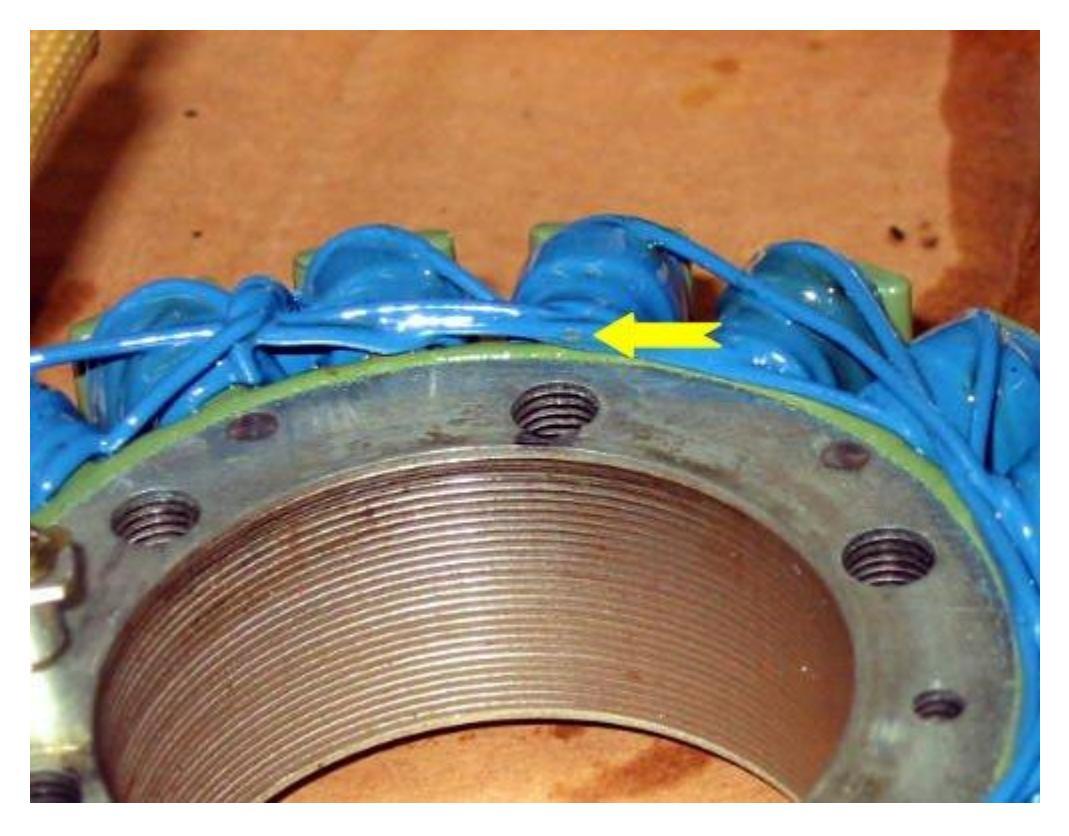
Yet another short circuit in the making can be seen here.

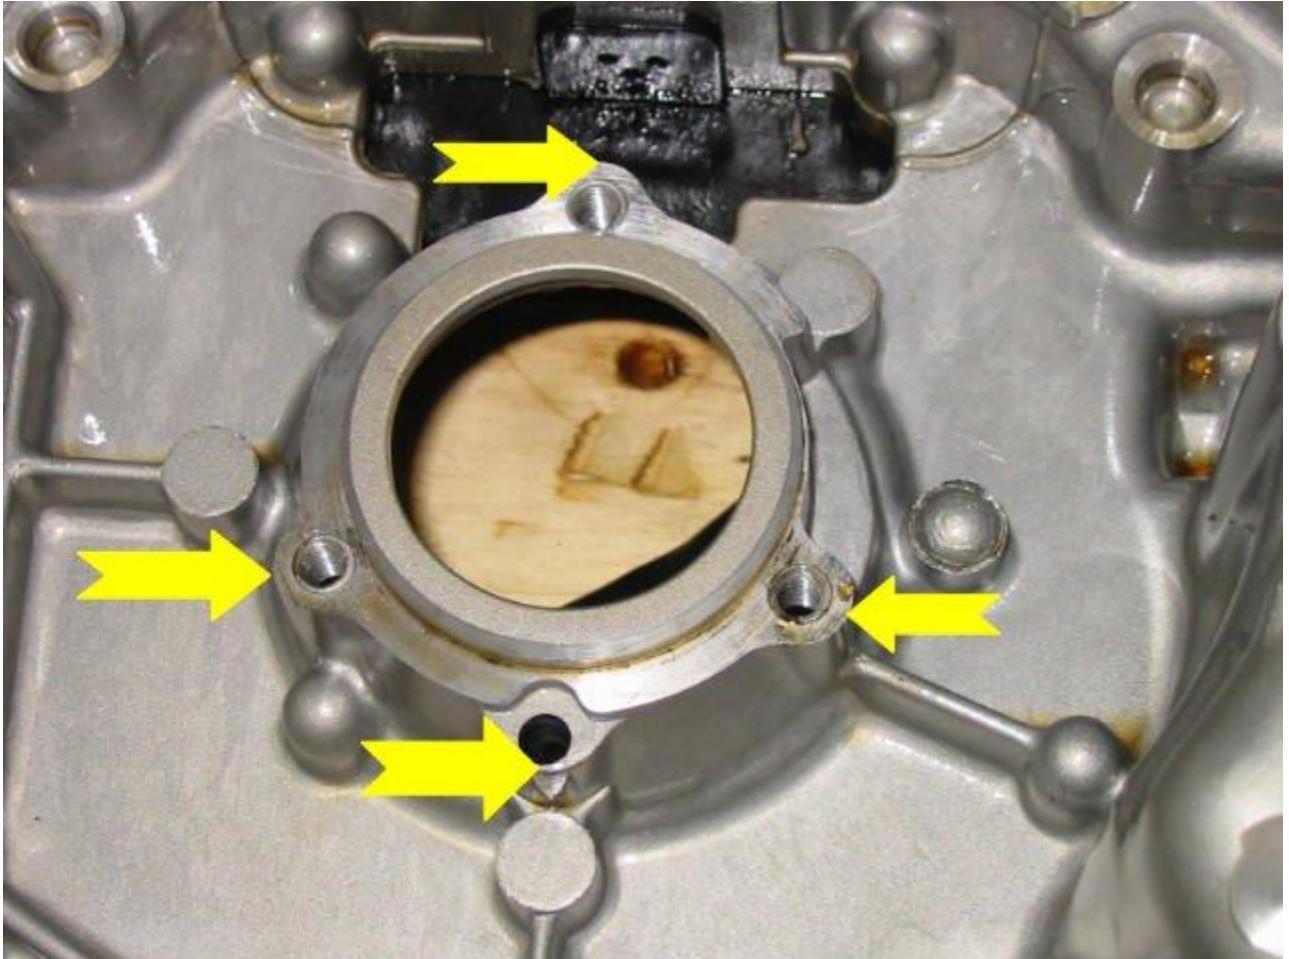
There are four locations where the problem is most likely to occur.

For those folks contemplating a stator replacement, it would be prudent to ensure that the stator wires have plenty of clearance with the stator mounting shoulder. If there is any contact at all the insulation will likely fail due to vibration and rubbing. It's a lot of work to remove/disassemble/reassemble /replace an engine to replace a stator, and even more so to do it twice.

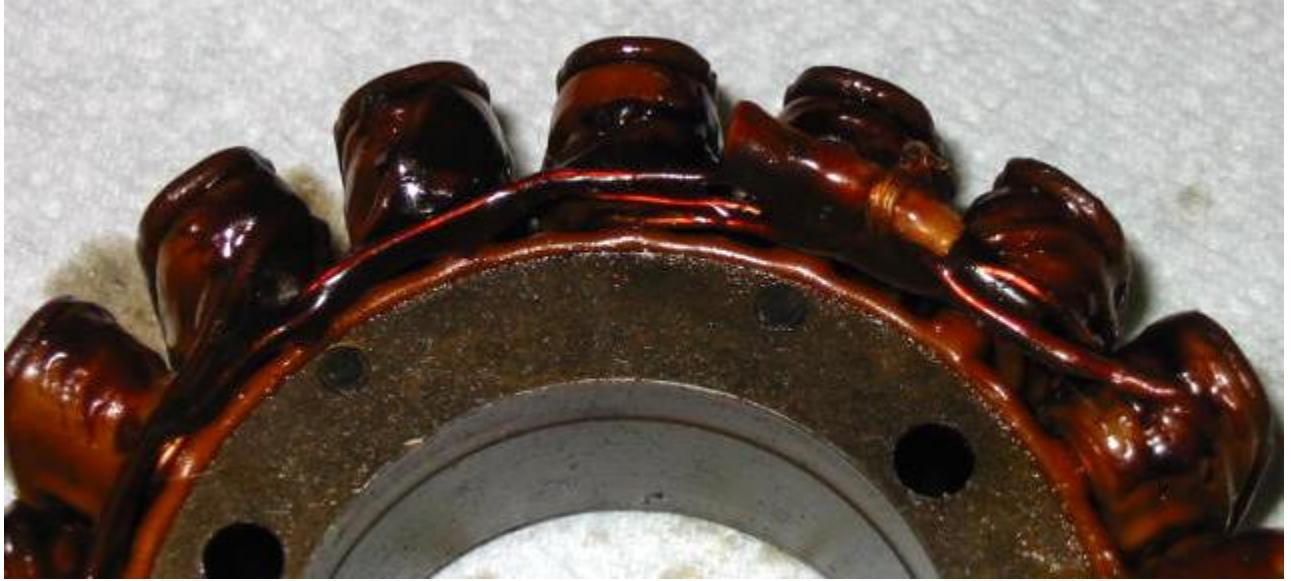
The wires between poles on the original Honda stator are routed to prevent contact with the mounting shoulder.

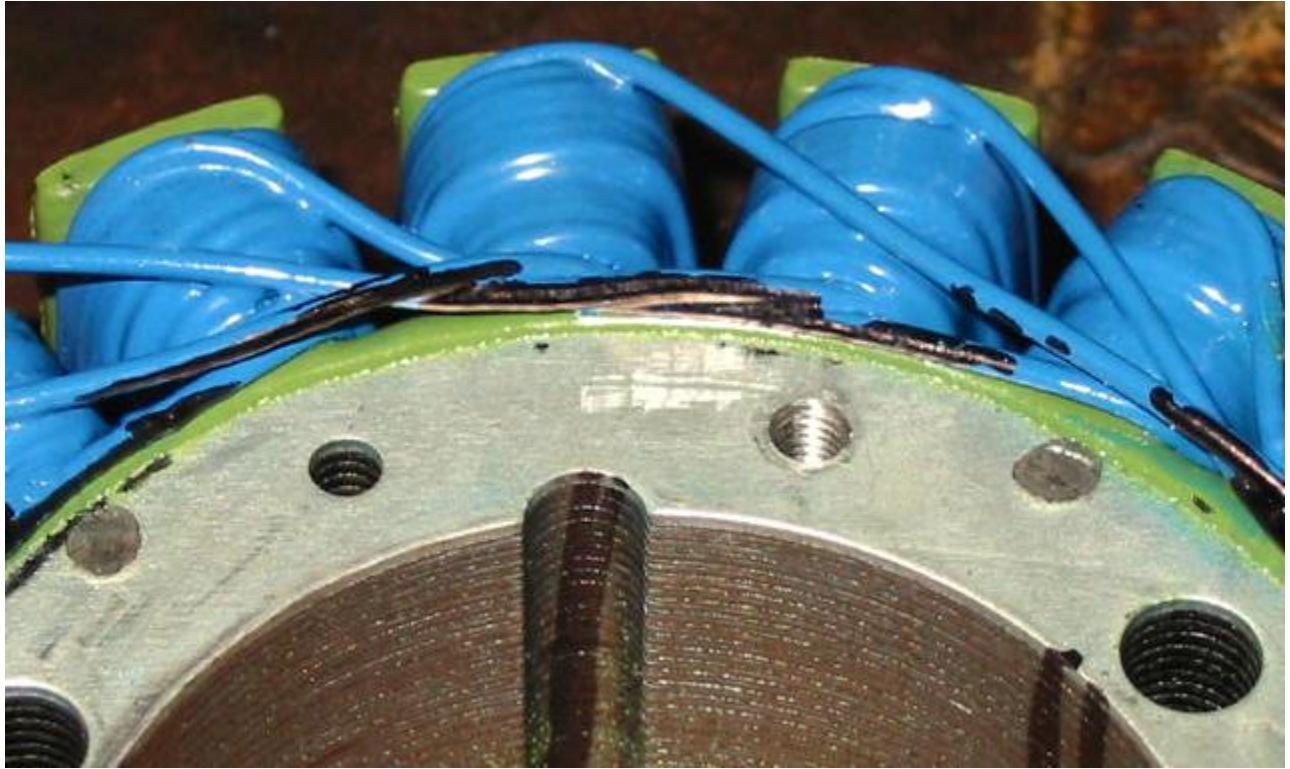
The stator was then removed and inspected for signs of rubbing as would be indicated by scratching of the marker ink. No problems were found.

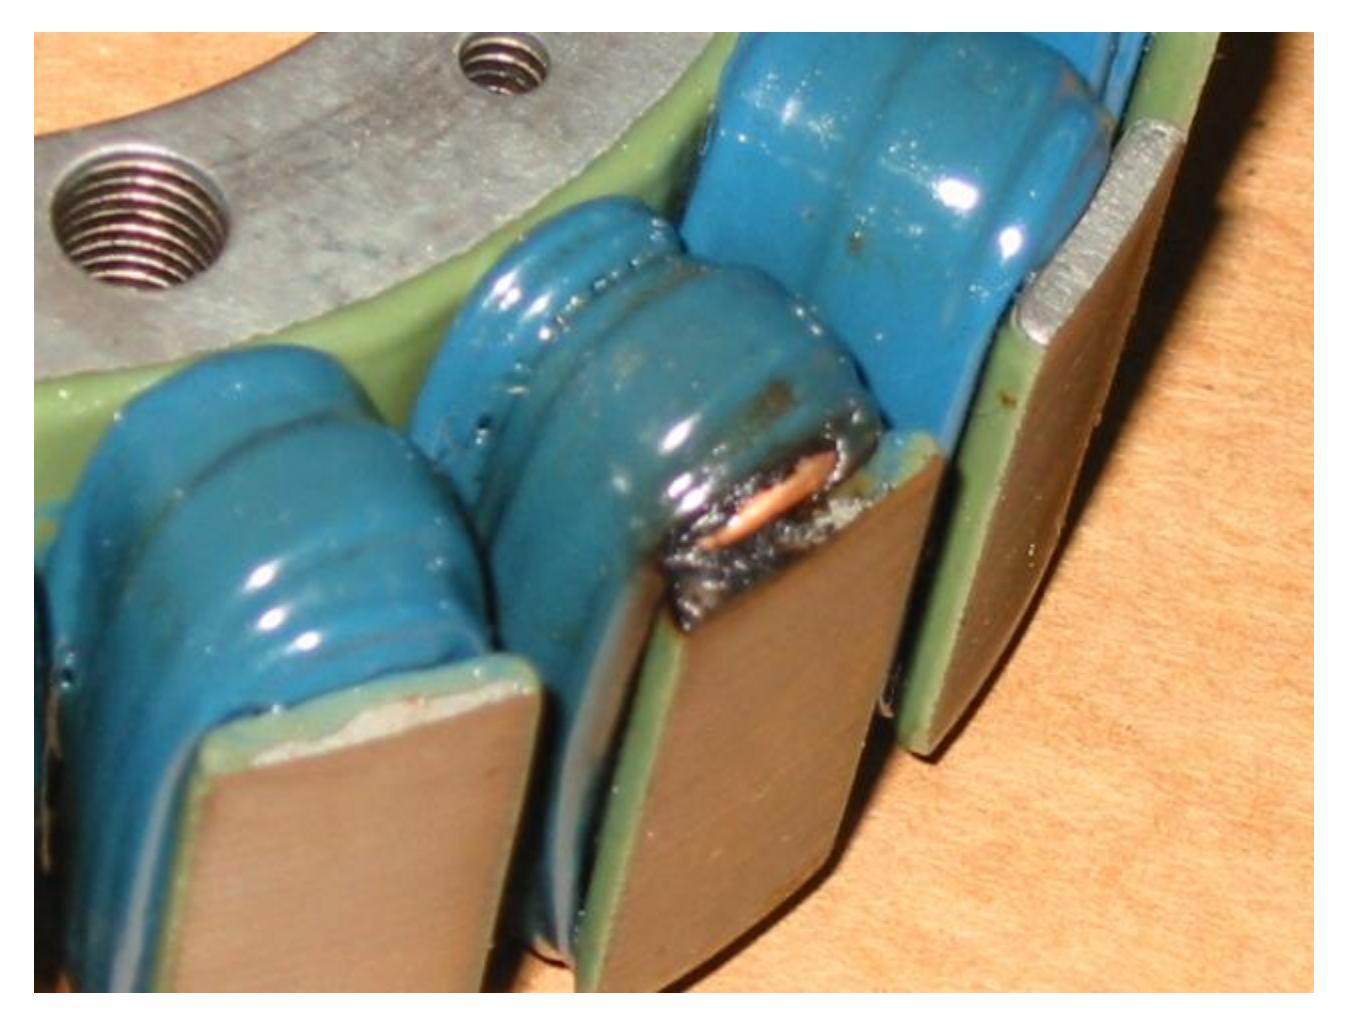
The failure mode was again a short to ground, but this time it was located on the side opposite the mounting shoulder.

This is definitely a manufacturing defect where the wire insulation chafed at the sharp corner of the pole.

some extra insulation and cushioning to reduce the likelihood that a wire winding could chafe against the sharp edge of a pole and short out to ground. In the above photo this insulation is either very thin or missing. Compare this photo to several of the others on this page and note the difference in insulation coverage.
