Alternator Stator Failure and Repair

Revised 4-1-2009

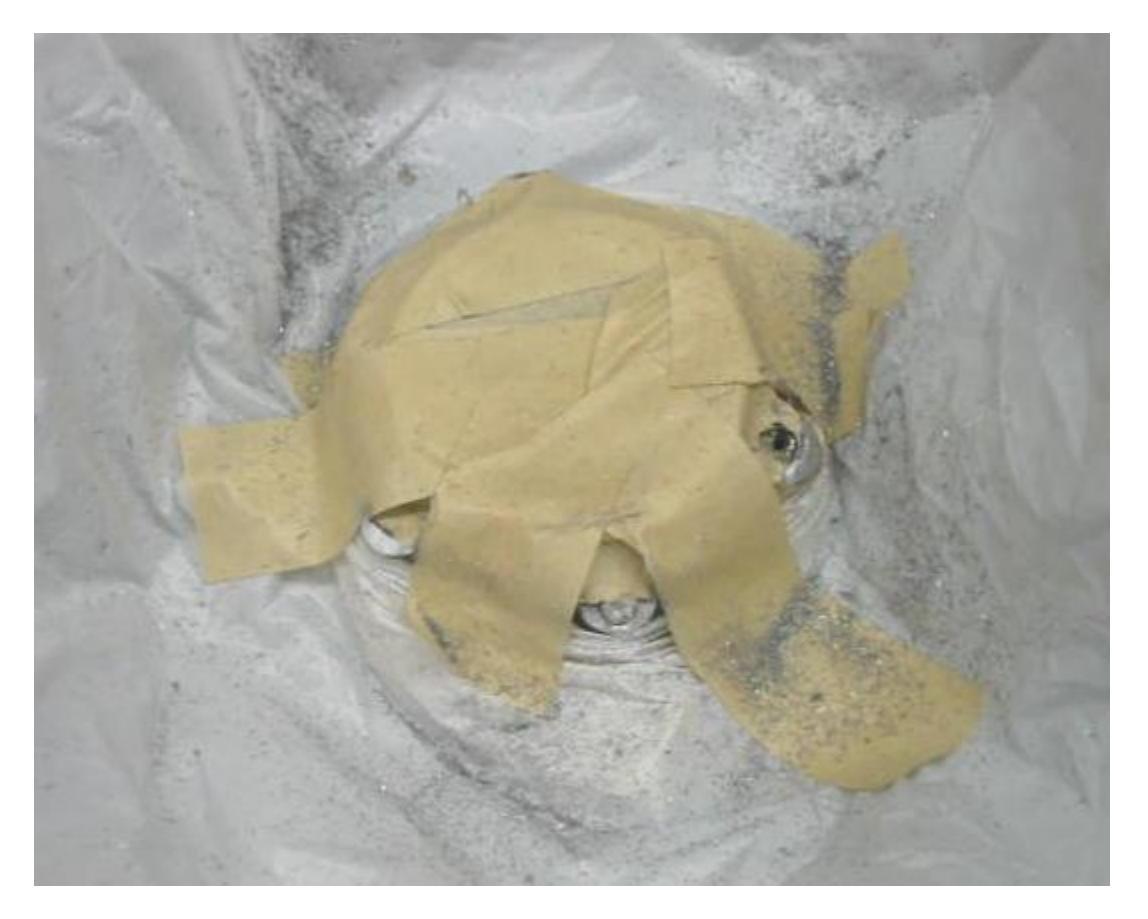
This is the mounting shoulder after the four corners were trimmed.

The cutting operation created many metal filings. The vast majority of the filings were caught with the plastic bag and masking tape, although a few strays ended up inside the rear engine case. Much care was taken to ensure all remaining filings were removed using multiple sequences of flushing with a solvent, vacuuming, and blowing with compressed air. This is very important because **a single filing in the wrong place could destroy the engine**.

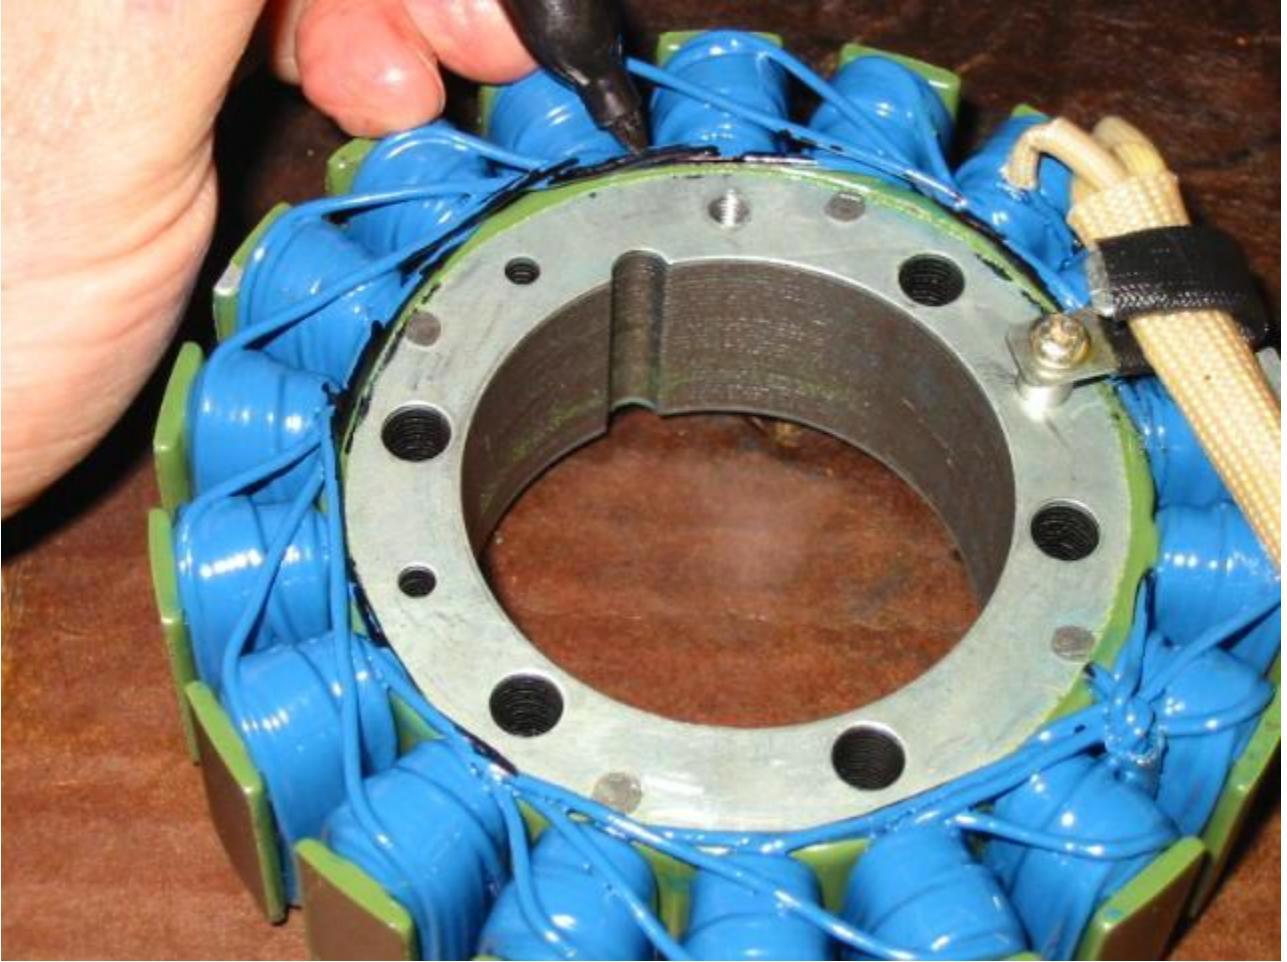
A test fit was then performed. The stator was carefully set in place and rotated slightly by hand while pressing sideways against the mounting shoulder in all directions.

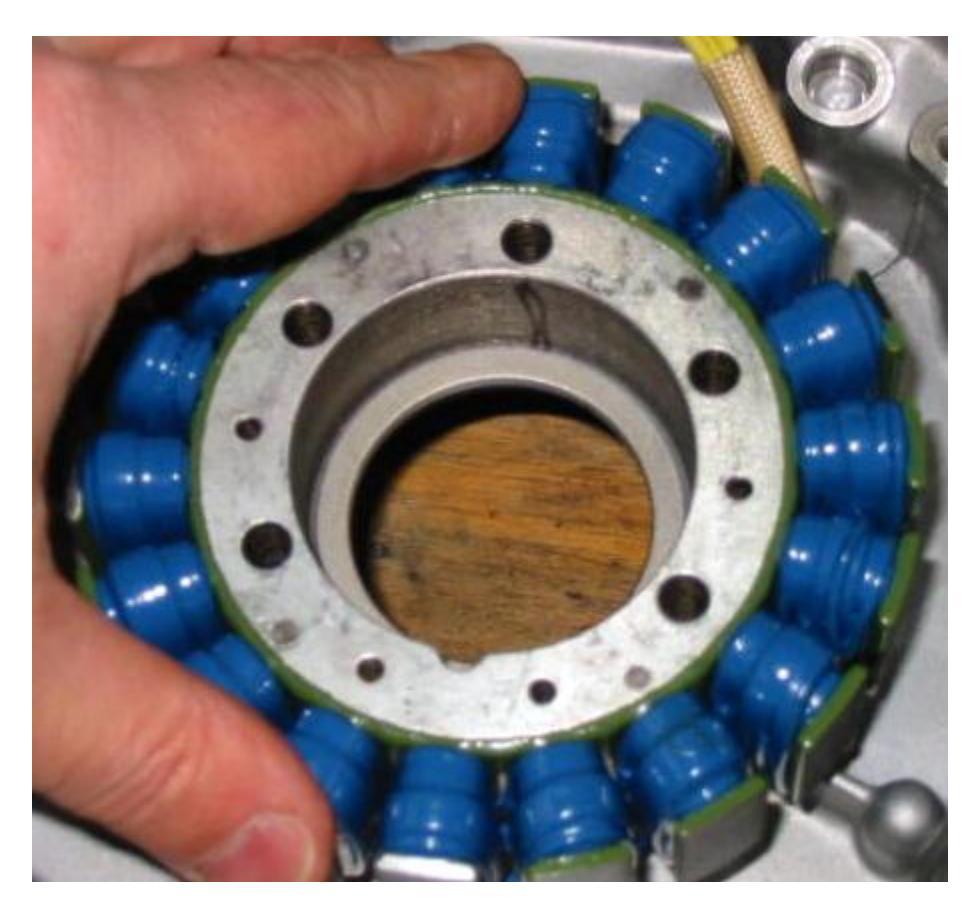
The stator was then removed and inspected for signs of rubbing as would be indicated by scratching of the marker ink. No problems were found.

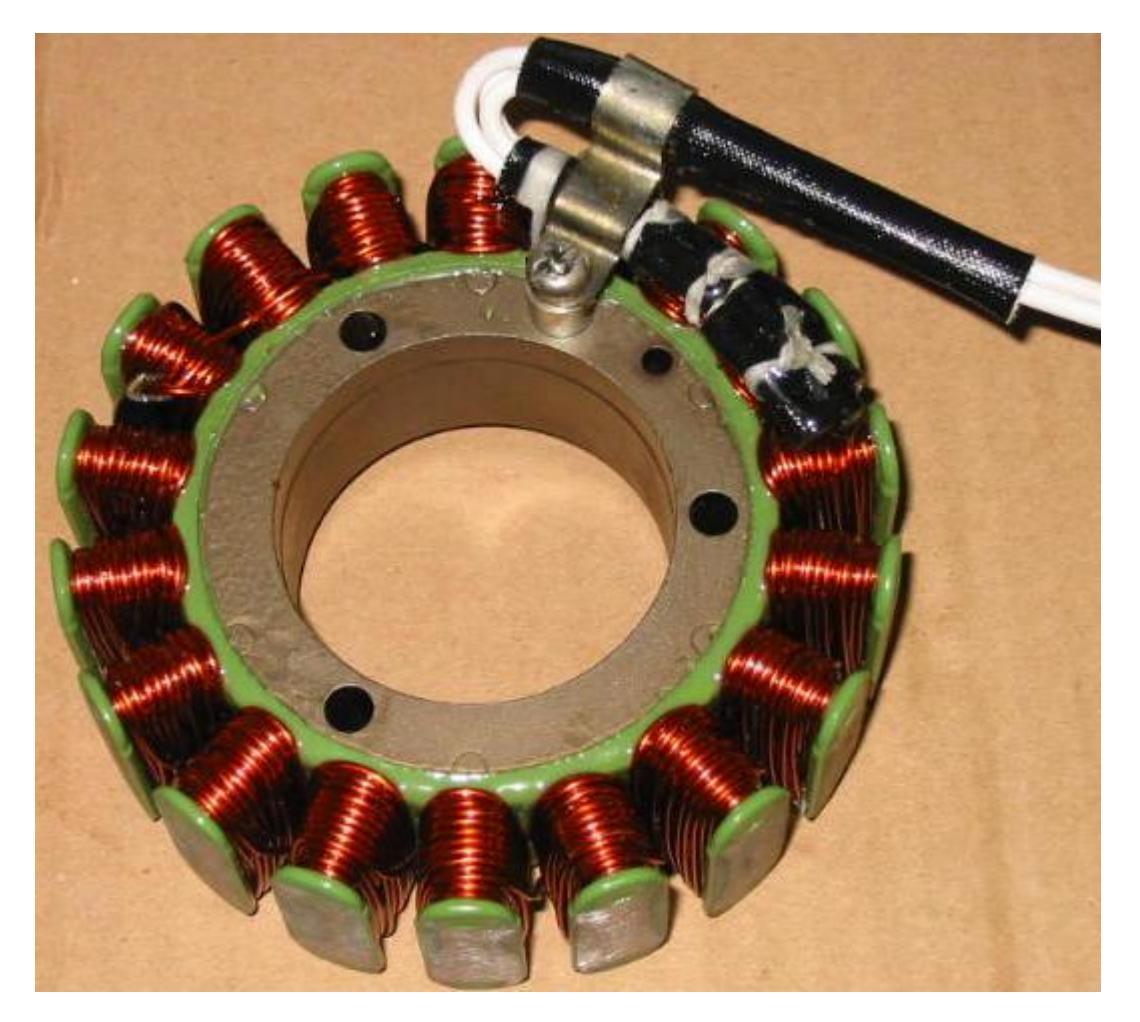
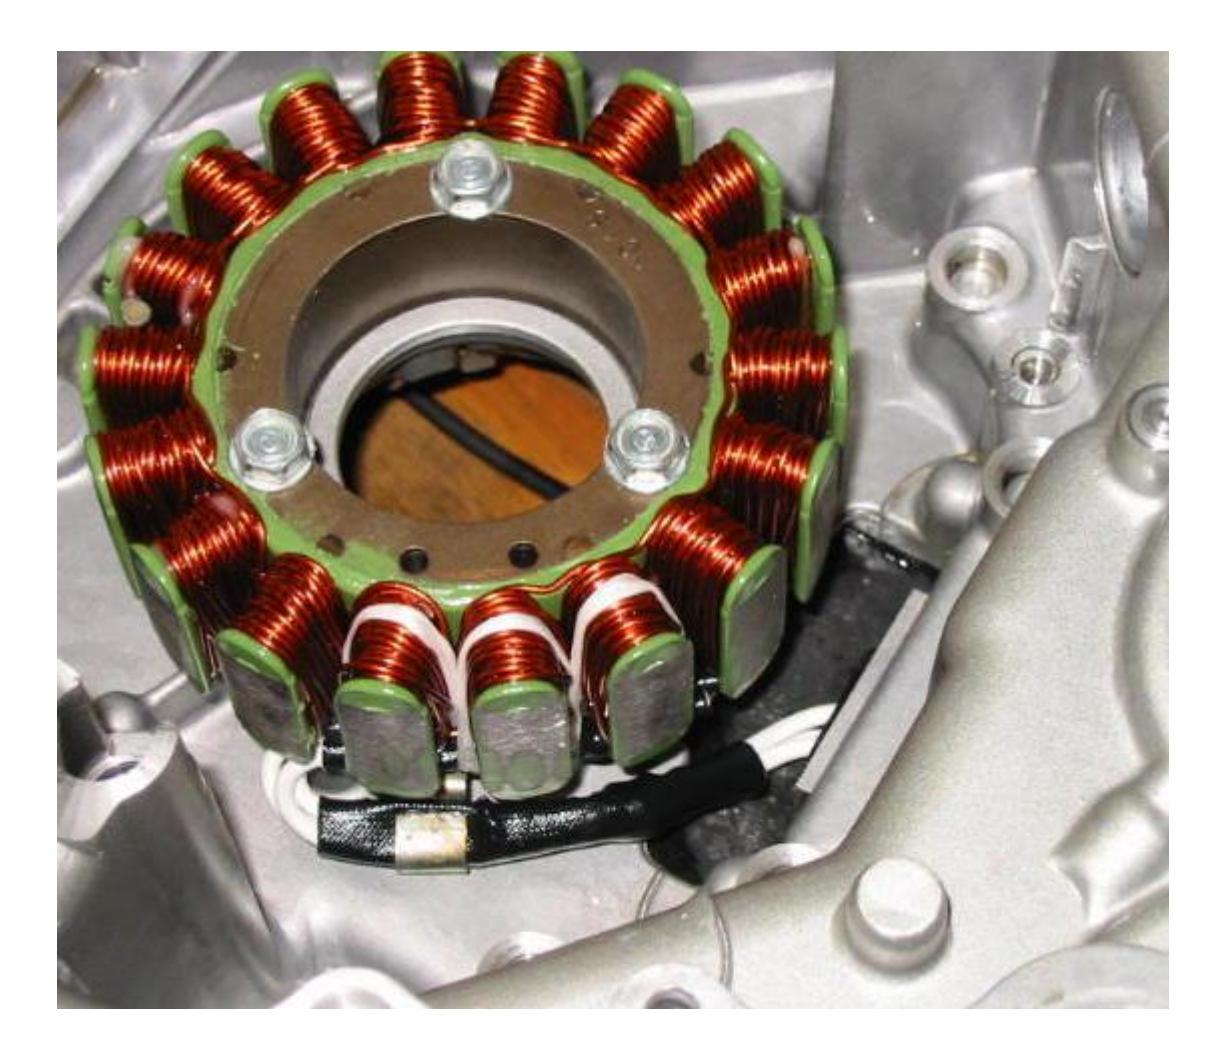
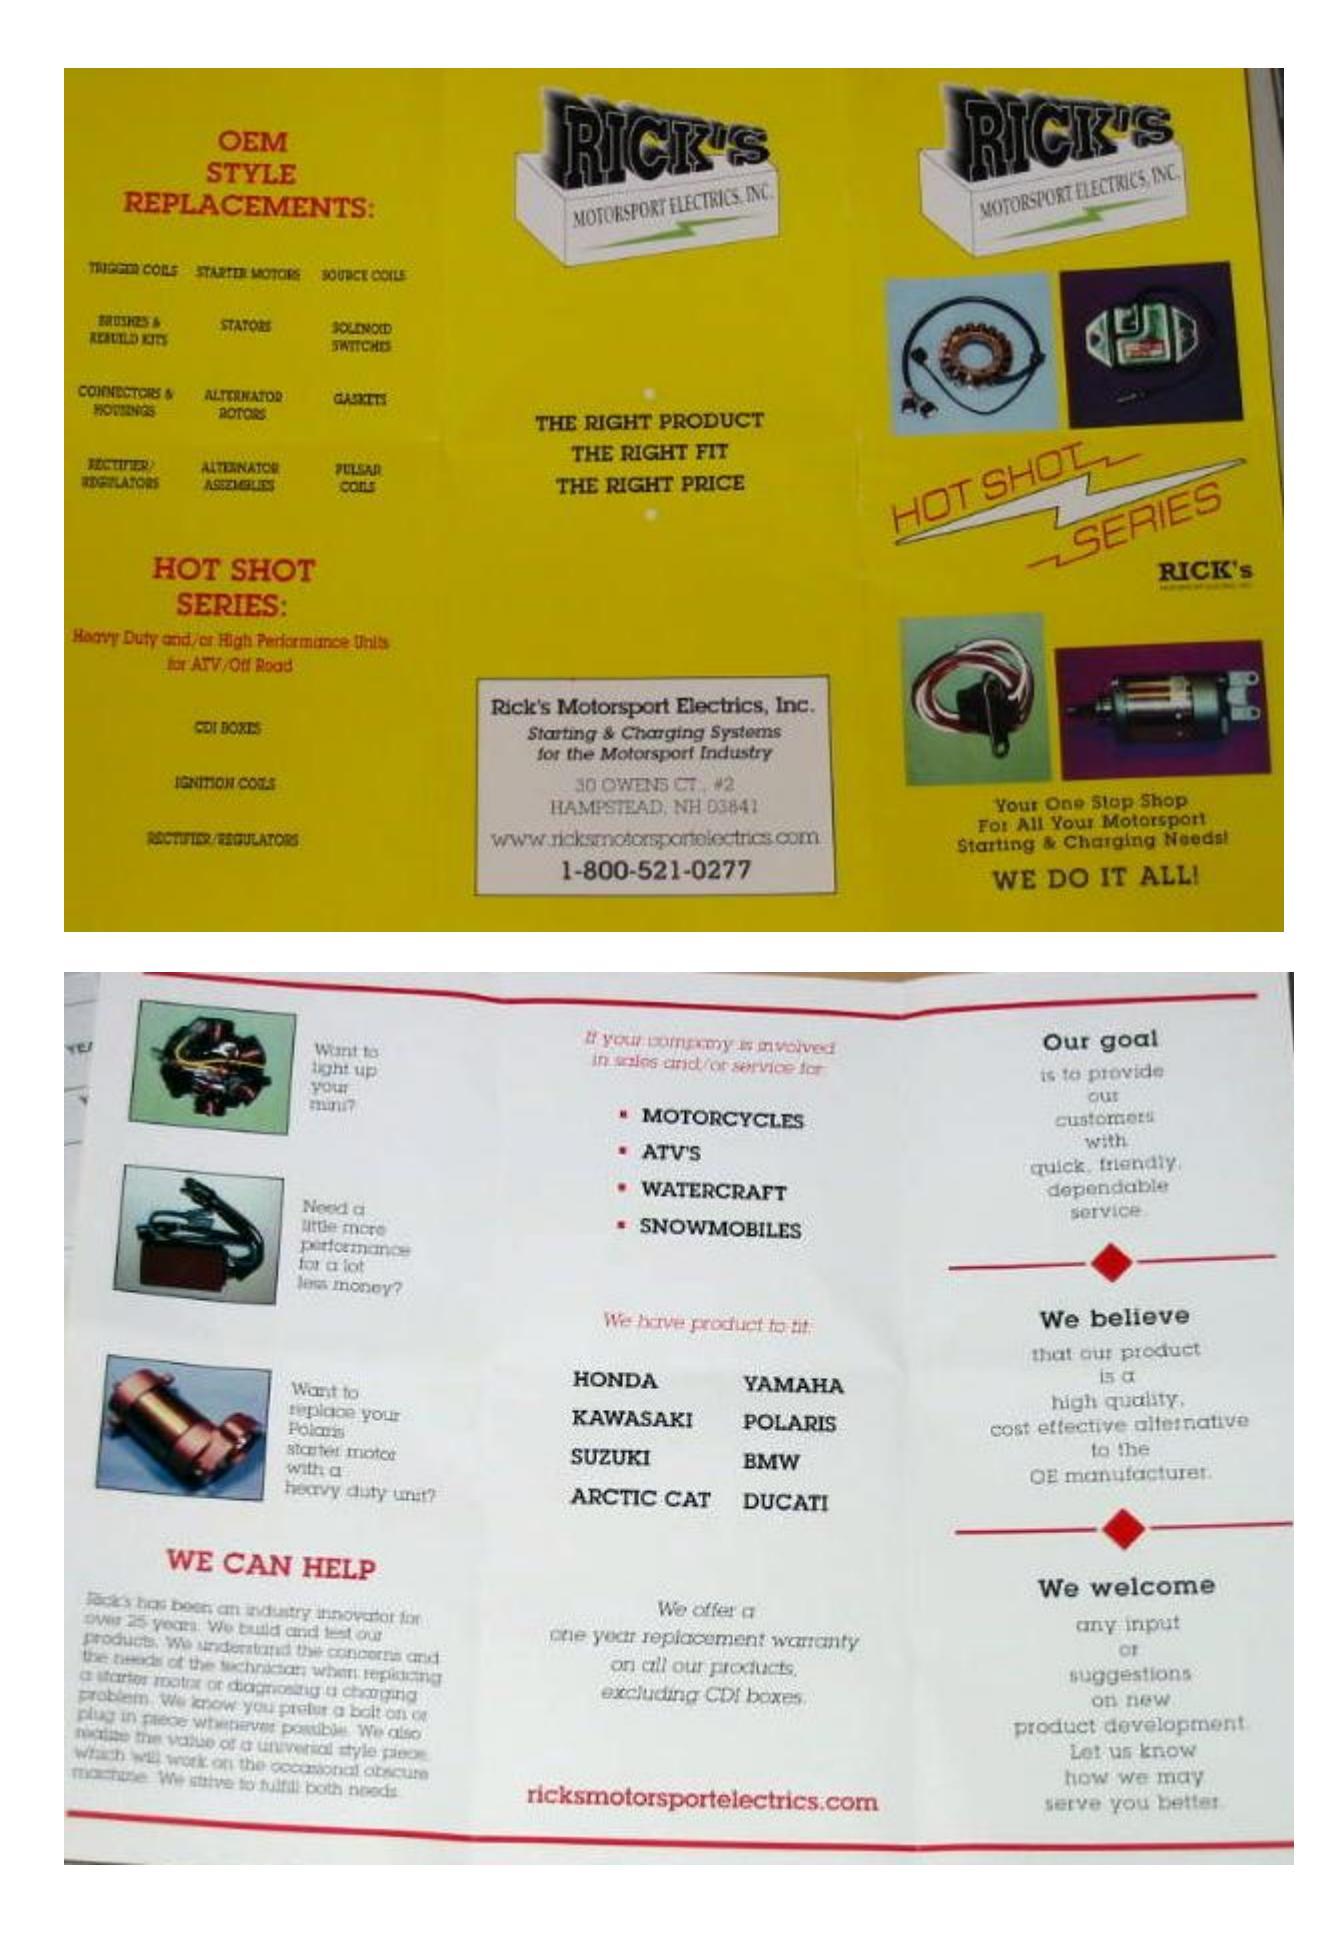
Rick's rewound a couple of stators for other bikes I own. The work appears to be of high quality as can be seen in the photos below. These have also proven to be very reliable.
